COLD BRIDGING

The Building

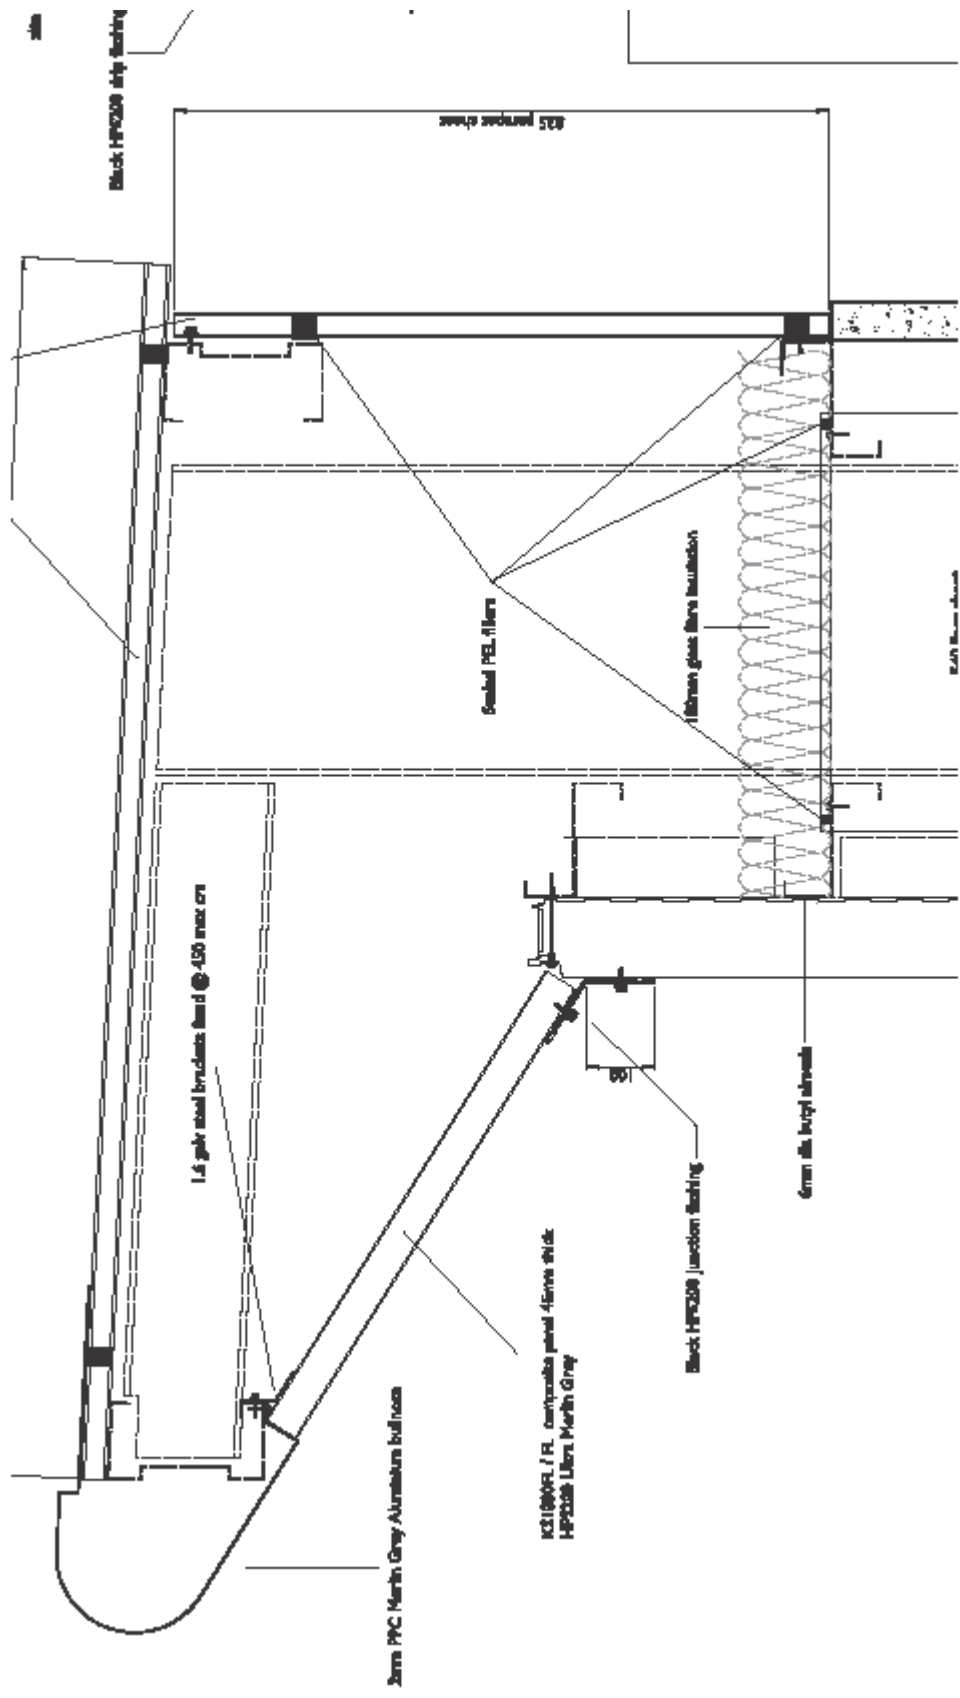
EXTRACT OF SUB CONTRACTOR'S DETAIL

- a) The sub contractor has proposed closing off the parapet void by using a steel sheet laid across two proprietary cold rolled galvanised steel rails.

- b) The Main stanchion (457 UB) penetrates from the warm interior of the building into the un-insulated void of the parapet. This will form a serious cold bridge into the building.

- c) The parapet perimeter is not fully sealed. Although foam fillers have been indicated at various points, these are vented and not fully sealed; Thus they will not stop cold air penetrating the void. It should also be remembered that the various cold rolled steel members are usually fabricated as standard components and will contain holes that are unused and there will also be gaps at section joints. These holes and gaps will permit further free flow of air and those supporting the closure lining will allow condensation within the void to drip into the building and allow warm air to leak from within the building into the void.

- d) A further cold bridge occurs with the rail adjacent to the gutter. You will observe that the external vertical parapet sheet here is single skin and in direct contact with the rail. The underside face of the rail is exposed within the heated area of the building.

- e) Other than the sloping fascia, all other faces of the parapet are single skin.
- f) There are issues with non fragility of the top sheet and the sheet closing the cavity. However, this is outside the scope of this study.

An f factor calculation undertaken via ourselves shows a figure of 0.36. This building is at best Humidity Class 2, thus requiring a factor of 0.5. Hence this is a major issue.

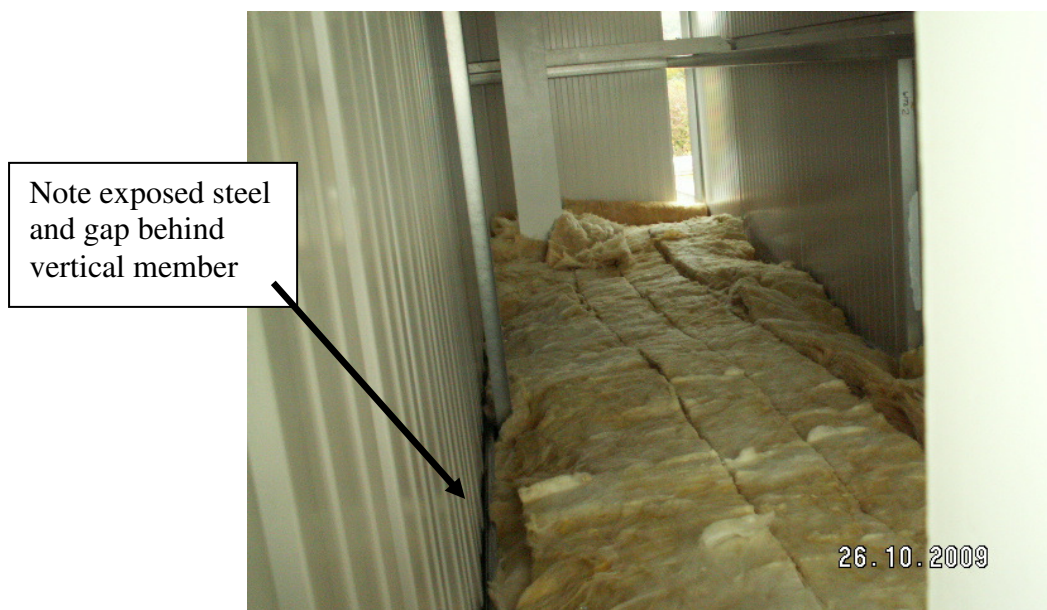
- a) The contractor used 2 layers of 180mm quilt instead of one over the horizontal sheet. However, this did not protect the sheet underneath. The quilt was not well laid and in several locations left areas of the rail below exposed. Furthermore, the quilt was not wrapped around components such as sag bars leaving further areas of exposed single skin steel in this area.
